# **INTERIM REPORT ON ARCHAEOLOGICAL FIELDWORK AT CASTELPORZIANO**

**April-May 2007**

Amanda Claridge  
Classics Royal Holloway University of London

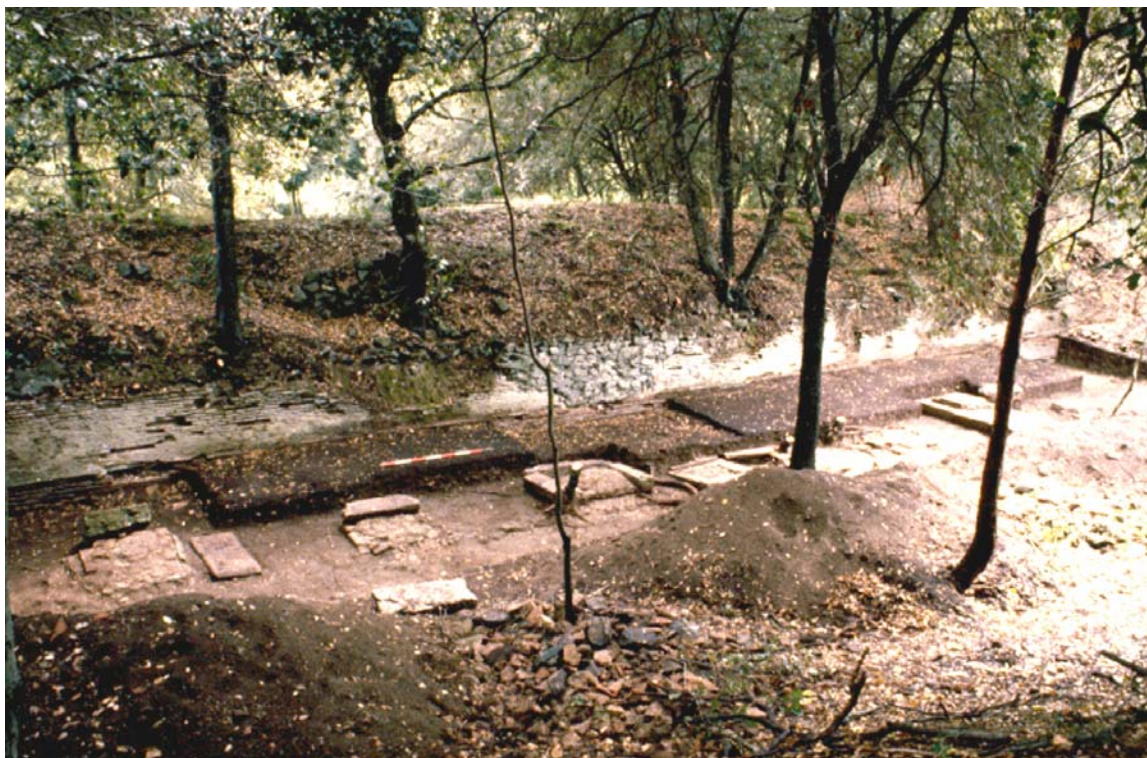
Fig. 1 Vicus, Forum area H, statue bases along the east side (1989).

The forum is one of the primary characteristics of a Roman town; its size and shape, and the kinds of buildings associated with it, can provide important clues to the size and socio-political organisation of the local community. The surveys of the exposed remains of the Vicus in 1984-90 established the position of the SE corner of its forum, with a group of temples (H1-3) on the south side and a line of statue bases (Fig.1), which indicated that the eastern margin corresponded with the perimeter wall of bath building A, but the rest of the size and shape of the square to north and west and remained in doubt, except for the angled placement of the northernmost and largest of the statue bases which could mark the NE corner (see *Castelporziano III*, pp.125f, figs 28-31).

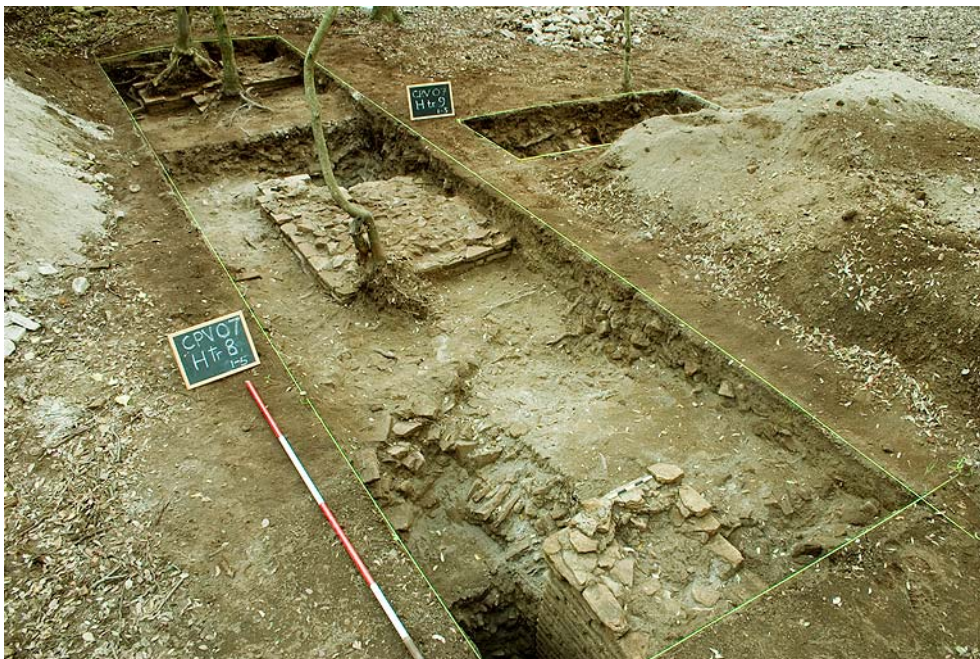
Fig. 4 Vicus, Forum area H, trench 8. View from south-east.

**H Trench 8** (2.0 x 8.5 m) extended from the west of building H4 so as to coincide with the trace of brick walling which had been observed in 2006 projecting at a right angle from its western flank, and to reach as far as the lower slope of an adjacent mound further the west (for plan see Fig. 3, above; photos figs 4-5, below). The walling attached to the flank of building H4 (3) measures 0.77 m wide and 1.00 long, constituting perhaps a monumental base or a buttress. Another brick-faced base (4) lies in line 2.30 m to the west, measuring c.120 x 1.30 m. It abuts the east side of a brick-faced pier (5), 60 x 60 cms square, to which a block of infill on the north side (6) was probably added at the same time as the large base. On the west of pier (5) is a door jamb (12), matched by another jamb (19) at a distance of 1.20 m. which abuts a group of walls located further to the west, on a N-S alignment (20 and 21). Unit (20) forms the corner of a room extending further to the north and west; unit (21) is the corner of another room to the south, with a door in its east wall. The trench was not quite large enough to show if 20 had a similar door. Although built separately, the join between the two units was not faced, indicating that they are probably contemporaneous constructions, undertaken by different teams (and perhaps signifying a property division). Building debris (7) containing sizeable lumps of collapsed walling filled the intervening areas of the trench, disturbed by a previous excavation (9) on the south side of (3)<sup>1</sup> and by a long furrow (8) or channel running at a diagonal between 3 and 4, ending in a shallow pit (10). A sounding on the south side of 3 identified three horizons of compacted rubble, the lowest a lightly concreted surface, perhaps the forum pavement, bonded with the foundations of 3, at a depth of 1.10 m. below the present ground surface. Deposits immediately overlying this surface contained pottery of the mid-late 3rd century AD. In another sounding beside 12 and 6 traces of a brick floor were encountered at a depth of about 1.0 m. (Fig. 6). Both soundings also identified a later horizon, involving a rise in ground level of c. 50 cms. The later floor level was missing in the angle between 6 and 12, destroyed by a previous excavation (13), but its makeup consisted almost entirely of bricks and limey sand. Pier (5) and the door jamb beside it (12) have both been rebuilt at the higher level, on the footprint of similar predecessors.

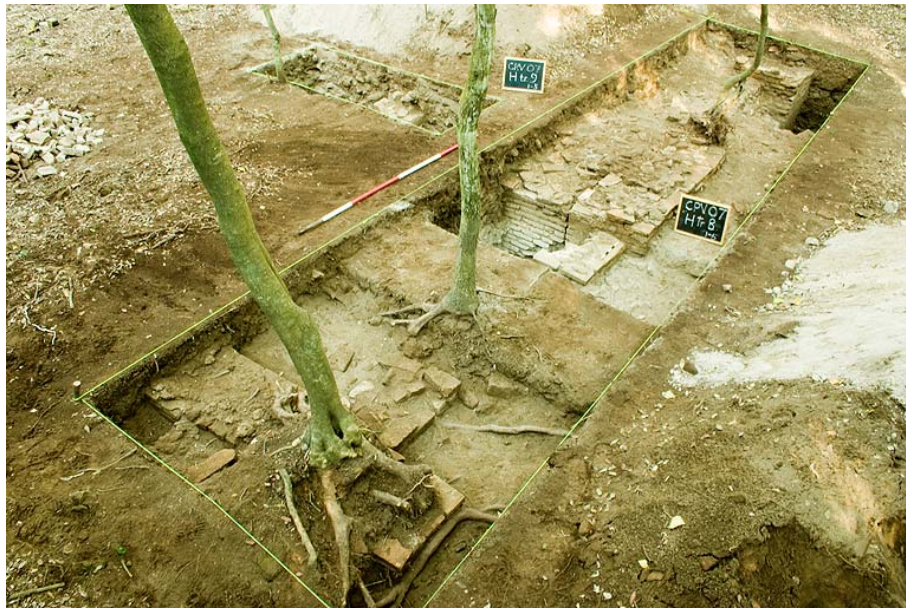
Fig. 5 Vicus, Forum area H, trench 8. View from south-west

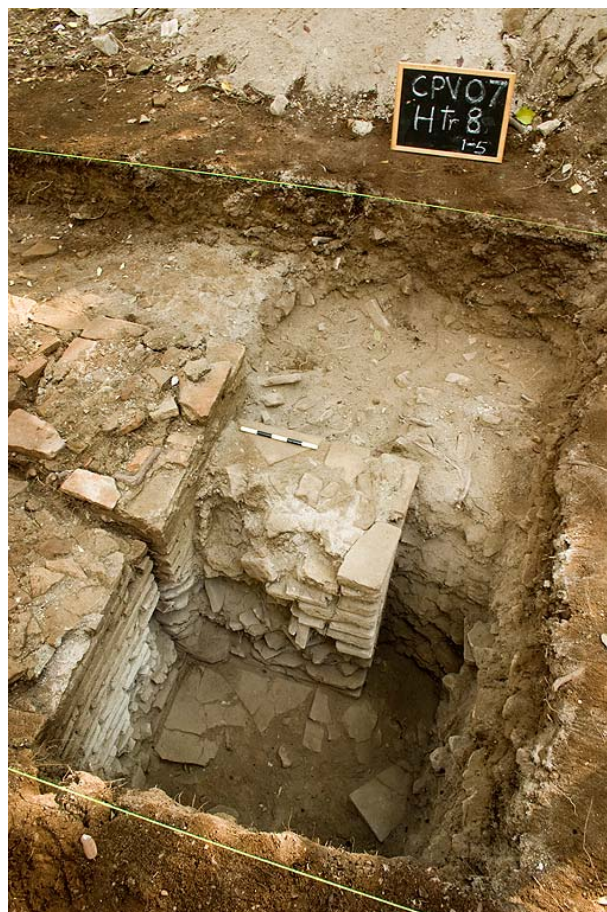
Fig. 6 Vicus, Forum area H, trench 8, detail of walling [6], [5] and [12], with tile flooring, viewed from north-west.

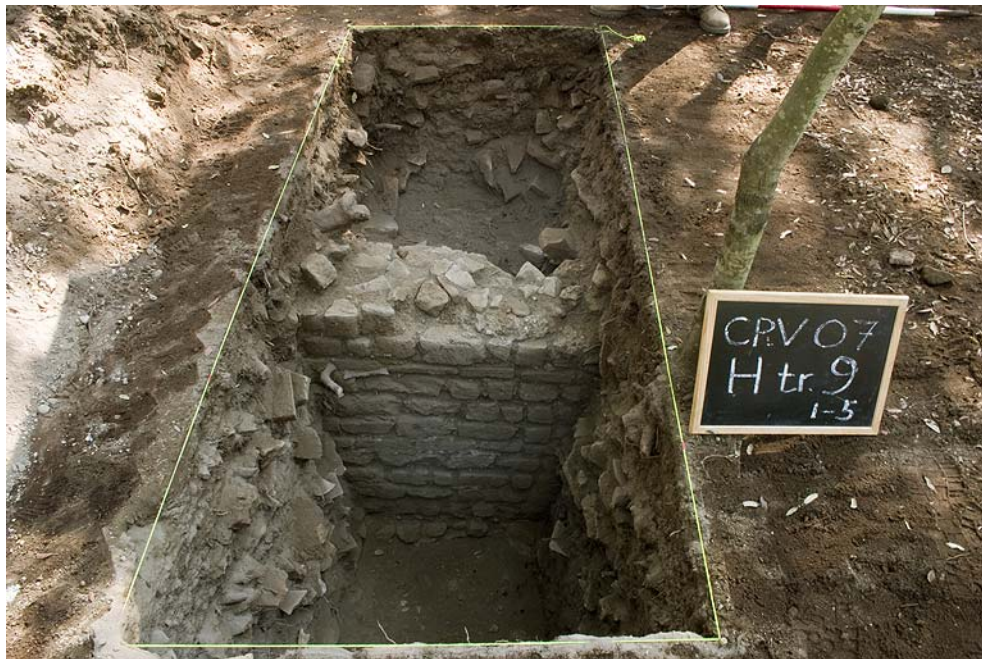
Fig. 7 Vicus, Forum area H, trench 9. View from north

**H Trench 9**, measuring 1 x 2.50 m (see plan Fig. 3, above, and photo below, Fig. 7) was opened to check whether a tree located some 3 m to the north in line with pier (5) had its roots in another similar pier. Instead, it exposed part of a continuous wall running E-W, faced on the north side in *opus vittatum* (3 courses of tuffelli alternating with 2 courses of brick). On the north side of the wall the deposits were completely different from the hard-packed building debris encountered on its other side, in trench 8: soft and ashy, they contained large fragments of amphorae and pottery and a variety of metal objects in association with coins of Maxentius (AD 306-312) and Probus (AD 276-282) in fine condition (Fig. 8). The E-W wall probably represents the northern boundary of the Forum square, extending west to form the north end of a porticus on the western side of the square, and to the east to meet the flank of building H4. It probably contained a doorway in line with the gap between the bases found in H trench 8 (3-4) and the furrow running between them (8).

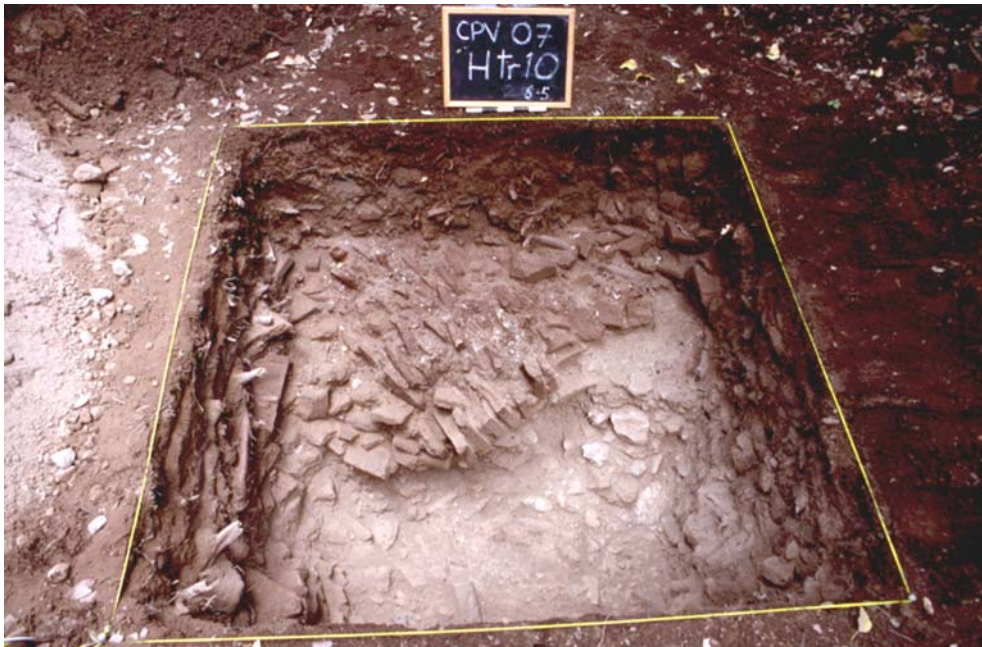
Fig. 9 Vicus, Forum area H, trench 10. View from east.

**H Trench 10** (1.5 x 1.5 m) was laid out 6 m to the south of H trench 8, in line with pier 5, on the other side of a large tree (for position see Fig.2), to check for further evidence of a portico or arcade<sup>2</sup> down the western side of the forum, to which pier 5 might have belonged. The area exposed by the trench was filled mainly with solid building debris (Fig.9), including a large piece of brick-faced walling which had collapsed at an angle on top of some underlying structure on the line projected for the portico. Clearance of some of the looser debris in the eastern half of the trench identified concreted rubble makeup like that found beside (3) in trench 8, at the same level, containing what could be a tile covered drain running N-S.

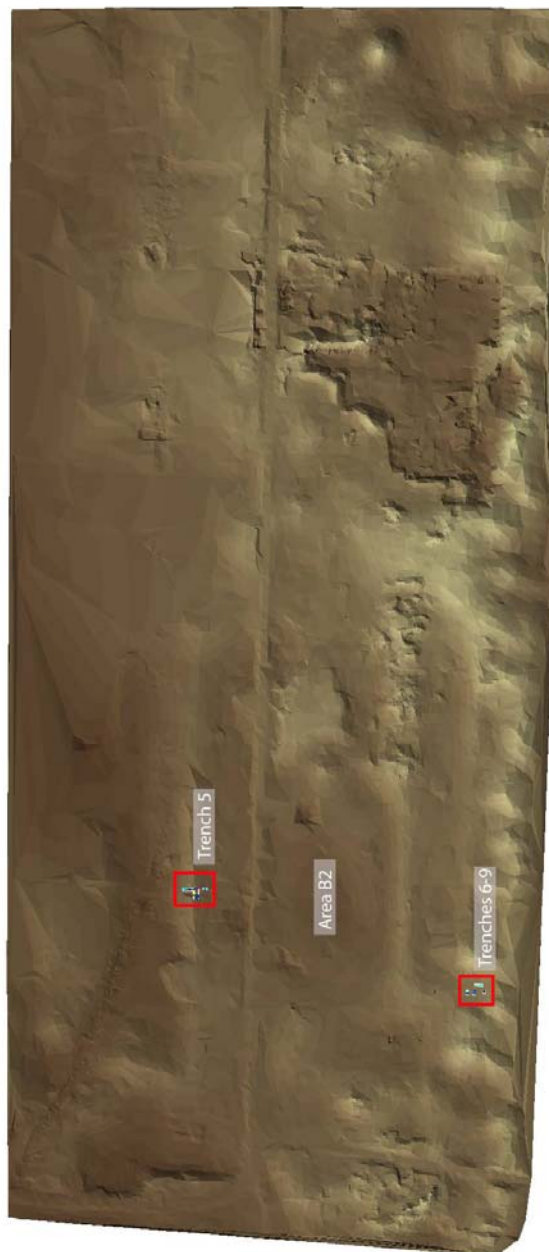
Fig. 12 Zone west of Vicus, DEM map, showing locations of B2 trenches 5-9.

The DEM in 2005-6, on the north (inland) side of the Via del Telefono, identified a rectilinear mound running parallel with and adjacent to the Via Severiana (Fig.12), associated with a scatter of building debris, including fragments of roof tile. In its length and elevation the mound closely resembles that investigated in 2004-6 on the seaward side (CPS04 and CPS05 B2: SS2 and SS3, CPS06 B2 trenches 1-4) and found to contain four parallel walls. Between them two mounds could constitute two sides of a huge rectangular porticoed enclosure, c. 260 m by 120 m, belonging to the Villa del Confine. In April 2007 a test trench was made to check the accuracy of the topographic model and the contents of the northern mound.

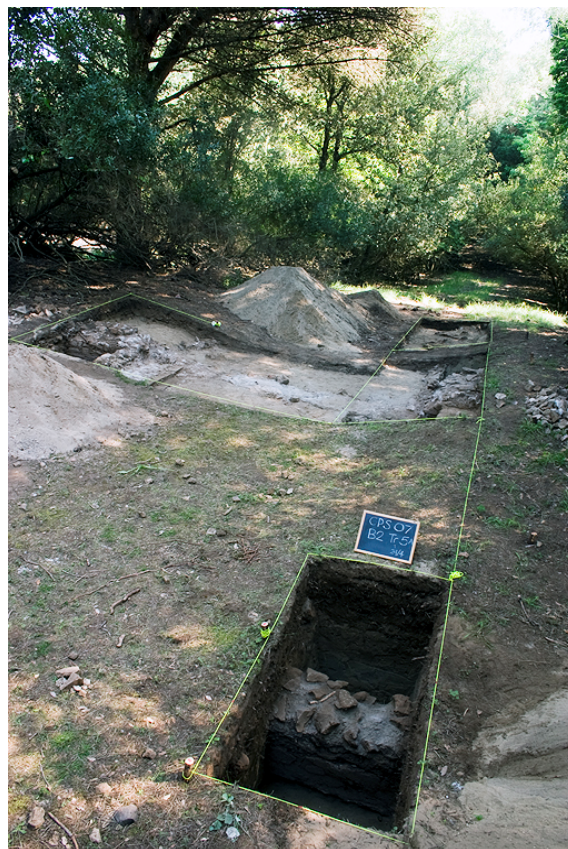
Fig. 13 Zone west of Vicus, B2 (north), trenches 5 and 5A, viewed from south.

Fig. 14 Zone west of Vicus, B2 (north), trenches 5 and 5A, sketch plan and section.

It was decided to examine the northern mound at the point where it was cut through by a modern forest track in the expectation that the cutting would only require cleaning to reveal the positions of any walls contained within the banks on either side. The section on the east side of the track was cleaned first, and duly exposed in its sloping cut one E-W wall [2], situated more or less in the centre of the mound, standing to within a few centimetres of the modern surface, with one course of tufa reticulate facing on top of one of brick preserved on the south side. The wall, c. 46 cms thick, was not faced on its north side, but had been constructed in association with a larger mass of concreted tufa aggregate, extending 92 cms further north, where it was roughly faced with tufa blocks (tufelli) and reticulate cubes placed on their sides, beyond which lay a deep deposit of almost clean sand. The western face of this extension had been destroyed down to the level of the modern track bed, but one tufa block of the lowest course of its original facing was preserved, at the south end, adjacent to the E-W wall, and a trace of concreted rubble core continued beyond the tufa facing on the north side, on a very shallow foundation, for a further c. 1 m. The trench was extended 4 m northwards and the rubble core was found to continue, albeit in even more damaged state (miraculously, the making of the modern track had not destroyed it entirely), for at least another 2 m. Beyond that only its debris could still be detected, nothing of its structure survives in place. At the south end, the wall had undoubtedly been bonded with the other walling, and can be presumed to represent a lightly built retaining wall, running N-S. That is, the modern track has very likely exploited an existing gap, an ancient passage through what was probably a natural dune. The course of the Via Severiana (well preserved in this stretch) leads to this same point before making a marked bend, suggesting that the passage represents the main entrance to the enclosure, and thus to the villa.

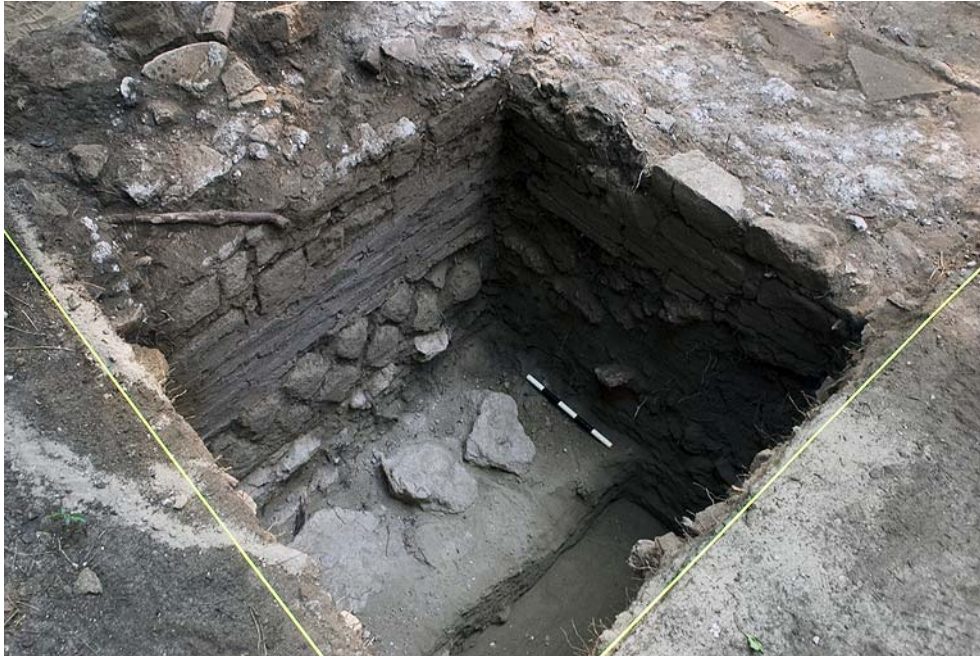
Fig. 15 Zone west of Vicus, B2 (north) trench 5, sounding in south-west corner exposing the rebuilding of the E-W wall. View from south-west.

the footing of a brick-faced wall extends to the south (for an unknown distance). A sounding in depth in the angle between this southward wall and the E-W wall revealed that their foundations are bonded, but the latter was founded on top of an earlier wall faced with reticulate tufa (Fig. 15). The sounding was deepened to establish the depth of the foundations of the reticulate wall as well, which were laid on a substantial footing of large irregular tufa blocks. A sounding beside the eastern side demonstrated that there too a reticulate wall had served as the foundation of the higher level wall.

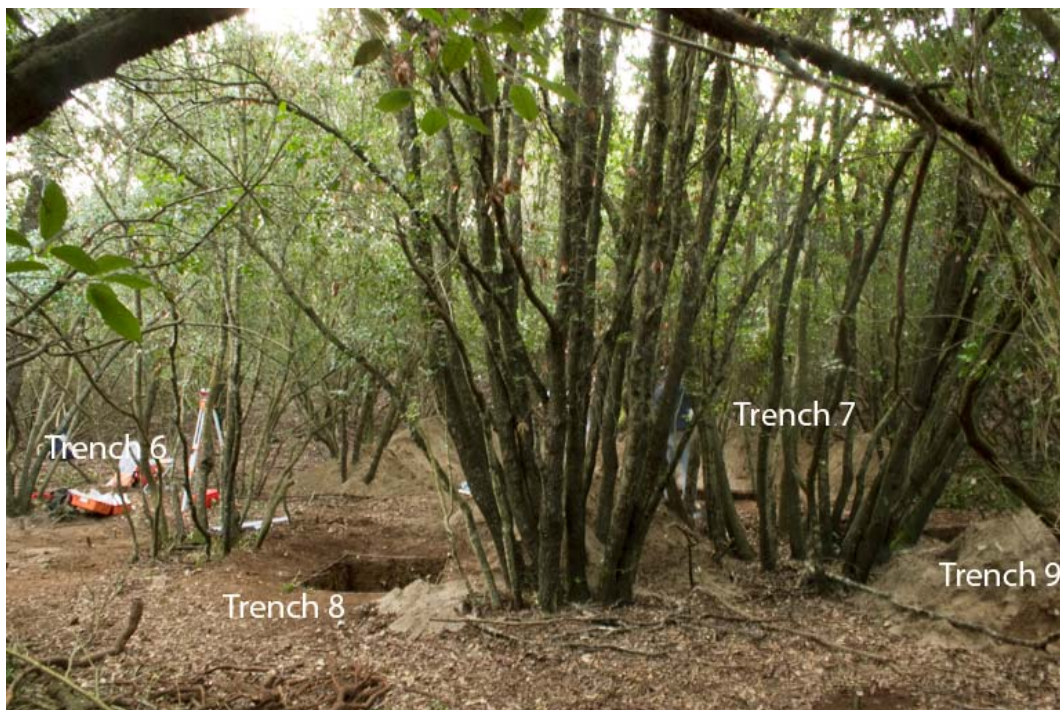
Fig. 16 Zone west of Vicus, B2 (south), trenches 6-9, viewed from west.

Fig. 17 Zone west of Vicus, B2 (south), trenches 6-9, sketch plan and section

Trench 6, initially 1 x 1 m. was plotted from the DEM in line with the reticulate wall found in 2006 and some 30 m further in the direction of the sea, in the midst of quite dense vegetation. The trench found the wall continuing seaward at a depth of c. 2 m., standing to a height of about 1 m. below the surface but no sign of a return. Trenches 7 and 9, sited further towards the sea, found a layer of concreted rubble sloping in that direction, perhaps a ramp (Fig. 18). The return of the reticulate wall was eventually identified by trench 8, again under 2 m of sand, reduced to its foundations. Two thick and distinct strata of clean sand overlay the seaward end of the N-S wall and the area beyond its E-W return. The style of reticulate facing, with large, irregularly sized cubes, and tufa blocks forming the quoins of the corner, indicate a date in the early empire. The wall probably represents the first phase, and on present showing was not replaced in a second phase.

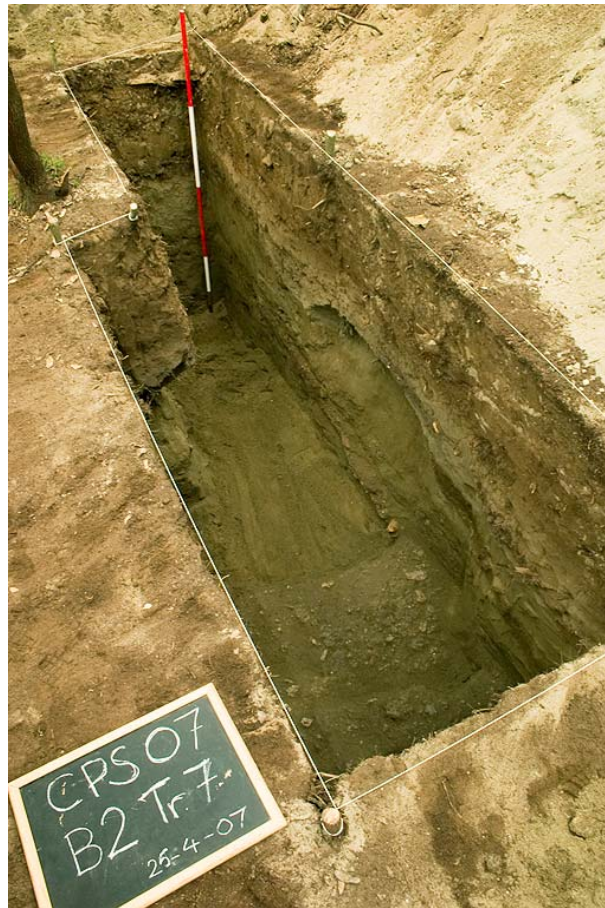
Fig. 18 Zone west of Vicus, B2 (south), trench 7, viewed from south-west.

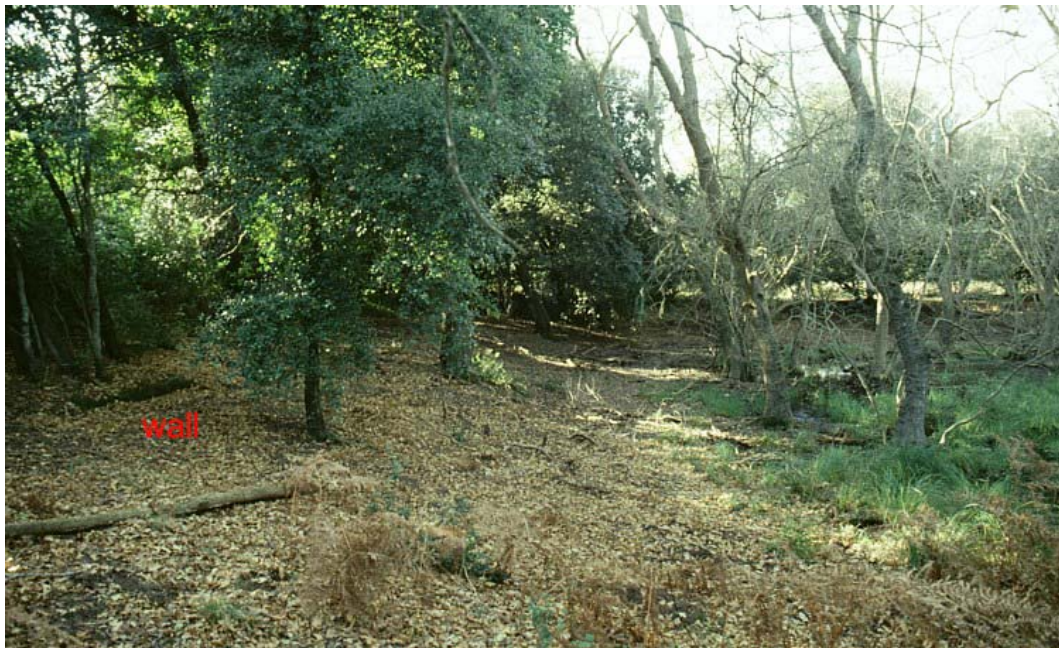
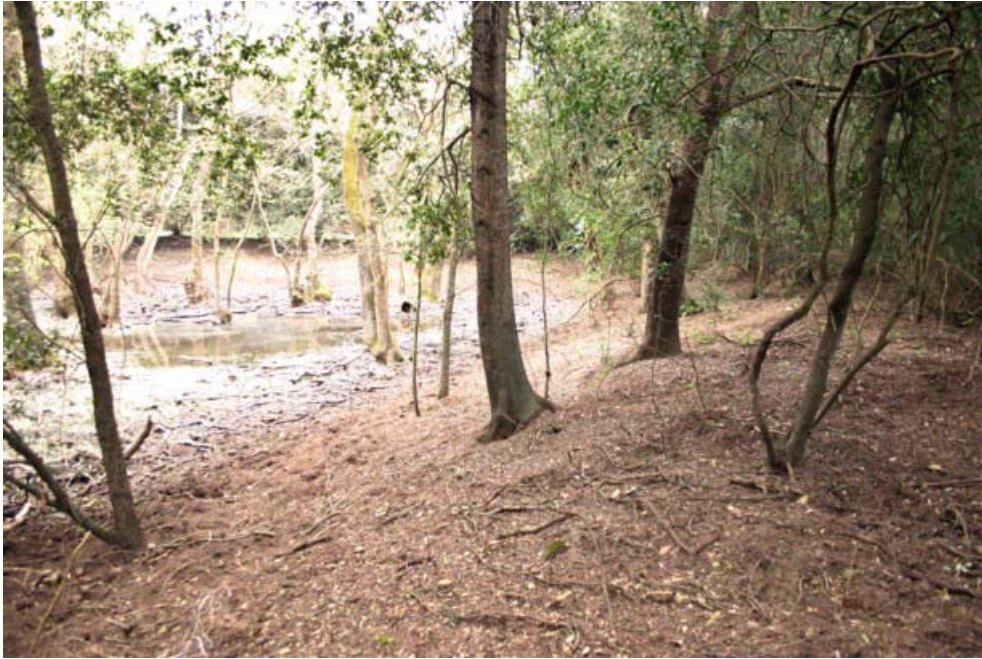
Fig. 19 Fish-farm D5, north-east corner.

Fig. 20 Fish farm D6, north side.

The two very similar sites D5 and D6 were plotted in outline for the carta archeologica in 1989-90 (see *Castelporziano III*, tav. I and p. 50). Each consists of a very large rectangular depression (Figs 19-20), with a marshy tree-filled lake in the bottom, and traces of reticulate walling and collapsed concrete vaulting around the upper margins. Scatters of pottery, fragments of mosaic flooring, white stucco and painted wall plaster on D5, the smaller of the two, suggested they dated from the late republican period. For the carta archeologica of 1989-90 they were simply described as 'ville a peristilio', but further reflection encouraged the theory that they could constitute ancient Roman fish tanks (*piscinae*), which are a feature of the Tyrrhenian coast and have been the subject of recent studies<sup>4</sup>.

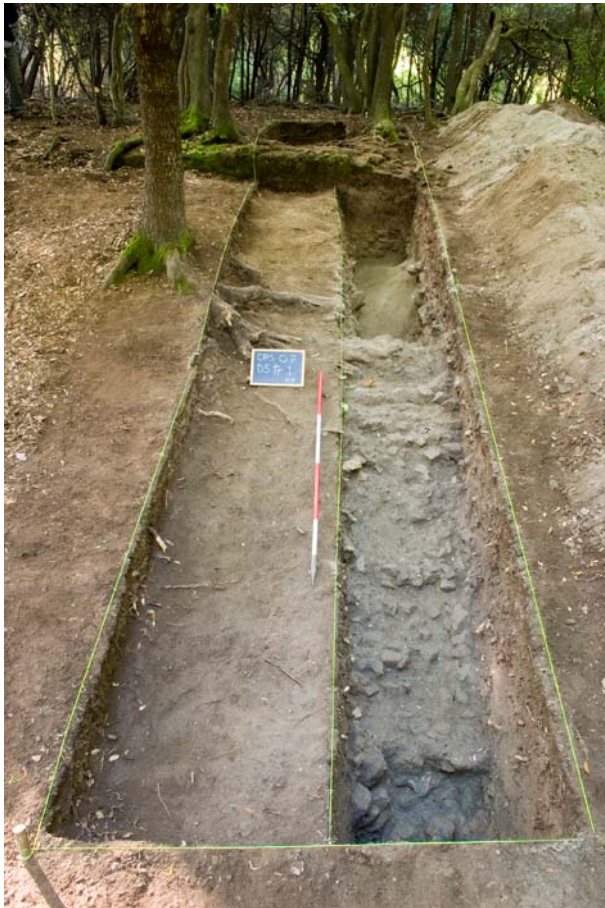
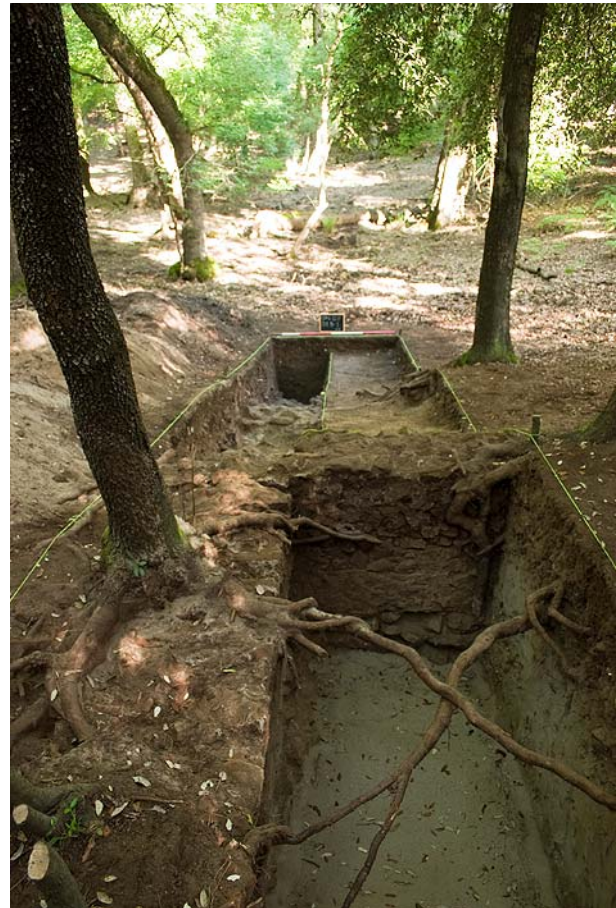
Fig. 21 Fish-farm D5, trench 1, general view from west.

Fig. 22 Fish-farm D5, trench 1, general view from east.

The trench was laid out on the east side of D5 where a length of *opus incertum* walling was exposed near the top of the bank and the ground scattered with fragments of black-and-white mosaic<sup>6</sup>. Initially 2m wide (later reduced to 1 m) it was positioned so as to include 2 m of the flat ground behind the wall to the east together with the entire length of the slope to the bottom of the pond, a distance of 10.80 m. (Fig. 21).

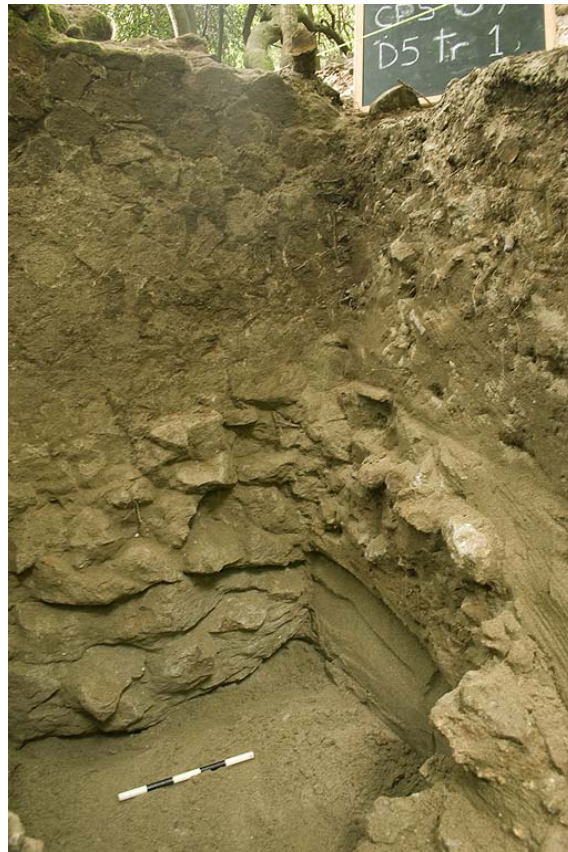
Fig. 24 Fish-farm D5, trench 1, detail of footings of wall [18] and adjacent features.

At the top of the bank, an *opus incertum* wall [18], composed of small tufa aggregate in a very hard, sandy cement of exceptional durability, 60 cms thick, is standing to a height of c. 90 cms, on foundations 70 cms deep. The lower half of the foundation consists of unmortared tufa lumps [25]. On the east (away from the pond), where the ground forms a level plateau between D5 and the next depression (D6), the excavation uncovered another wall [19], not quite at a right angle to [18] and now detached by some slight displacement but constructed at the same time on a common foundation and once bonded with it (the position of the return was provided for by the builders of
